HMS Hampshire 100

Survey Report

Location: Atlantic Ocean, waters west of Orkney, Scotland

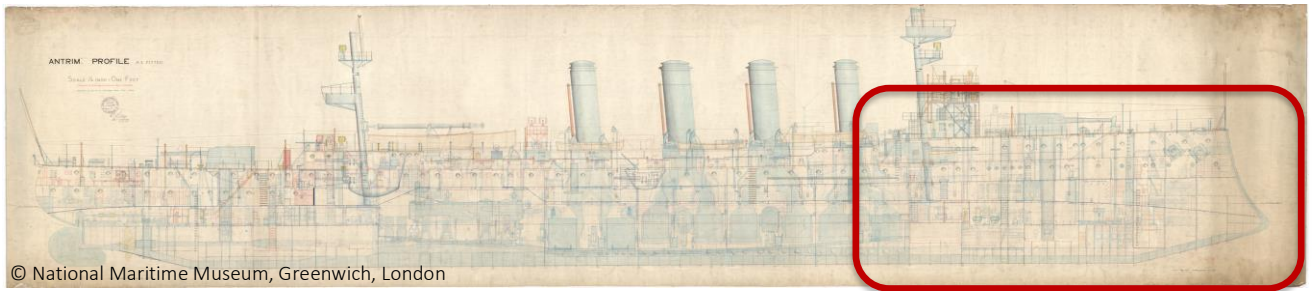
Figure 33: The Bow Section

The stem is intact from the top of the tapered vertical armoured belt to the keel and stands approximately 7.5 metres to the highest point. There is no evidence of damage to the remaining stem. The Boat Deck and the Upper Deck forward of P-turret have been crushed so that the upturned bow now rests on the top edge of the main vertical armoured belt. The forward compartments above the main vertical armour belt were lightly protected and held crew spaces on two deck levels. Scuttles (portholes) were housed in the Boat Deck and Upper Deck and are visible in Figure 35.

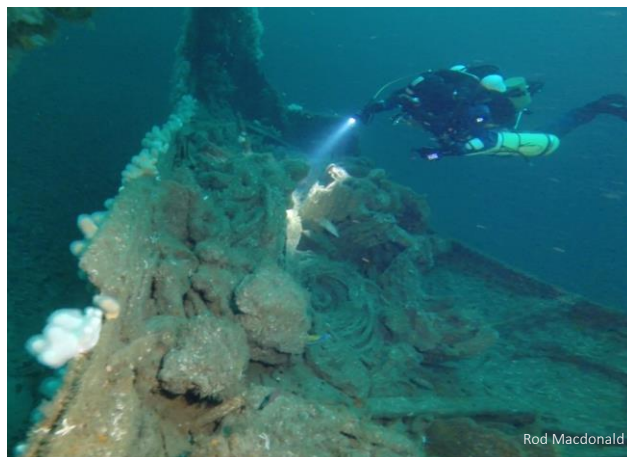
Figure 37: Looking forwards to the upturned stem

Looking forward towards the upturned stem (Figure 37), fragments of hull plating can be seen on the starboard (left) side of the ship, whilst on the port side (right) the remaining shell plating quickly reduces in height to meet the thicker tapered vertical armour belt plates.

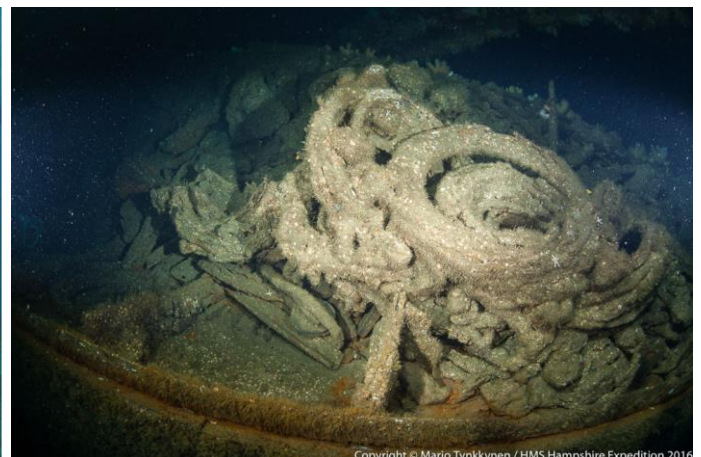
Figure 38: Warps of cable and debris

The internal deck is still present but sags downwards. Warps of cable and associated debris fill the space (Figure 38).

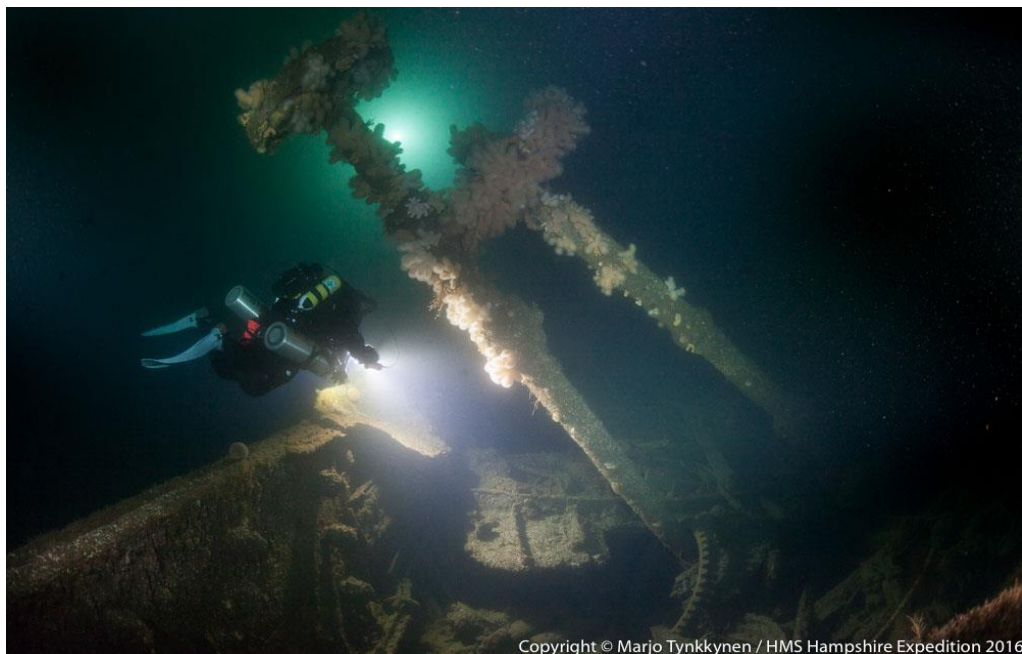
Figure 46: Forward anchor capstan gears and drive shafts protrude up from the bow wreckage

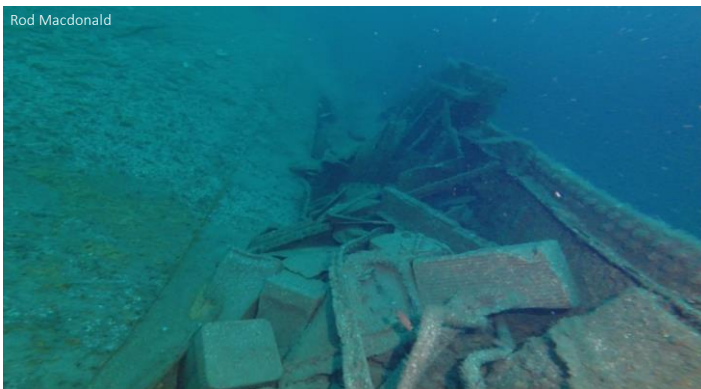
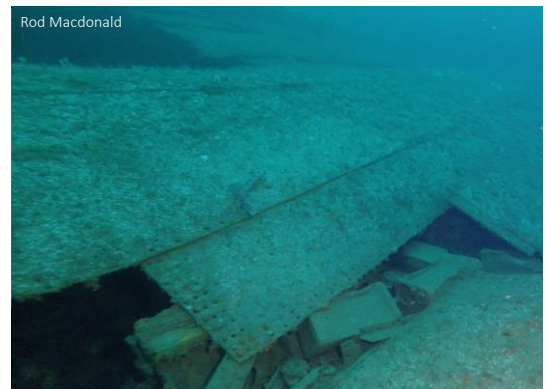
Ribbed brass boxes of cordite propellant in the exposed magazine for P & Q-turrets are being exposed by the collapse of the hull on the starboard side just as the hull reforms its shape at frame No 38 abaft the bow damage.

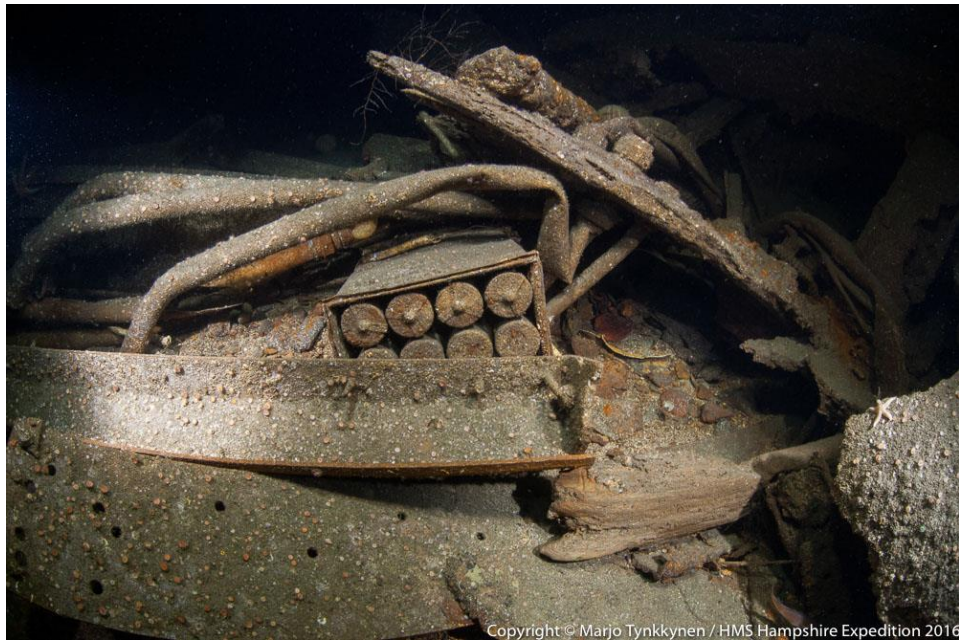
Figure 55: Box of 12 per QF brass cartridge cases containing cordite

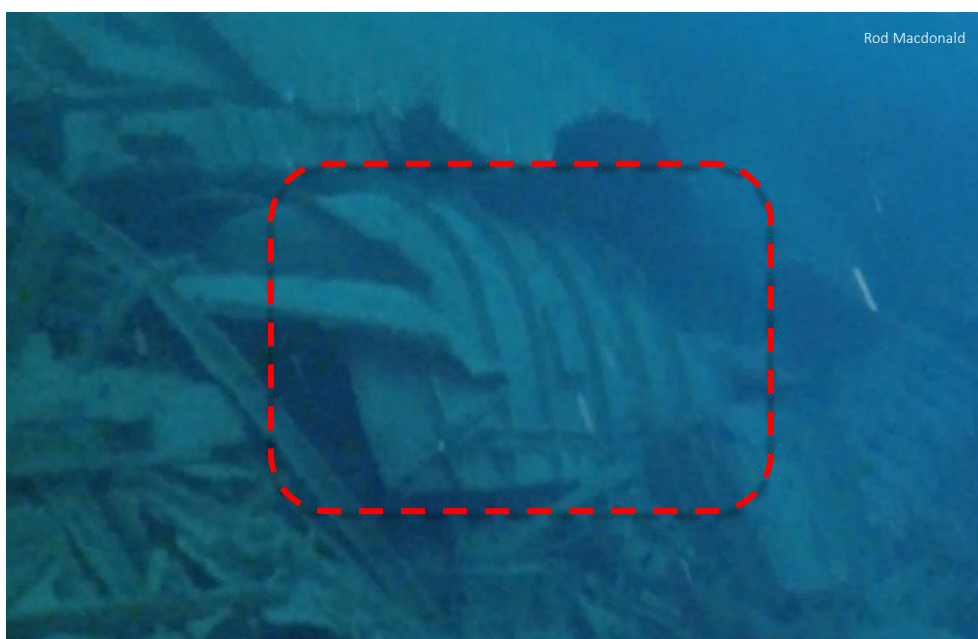
The Lower Conning Tower was a secondary control position located below the Bridge on the Platform Deck. It housed all necessary equipment to control the ship, including steering helm, compasses and telegraphs. To aid in reducing magnetic interference the walls of the room were made of brass with a solid brass transverse bulkhead forwards. This entire bulkhead is located at frame No 37 and lies athwartships in the bow area debris just forward from where the hull begins to resume its original shape at frame No 38. The bulkhead is uniformly curved inwards aft, consistent with the effects of a powerful explosion close by.

Figure 58: Buckled transverse bulkhead

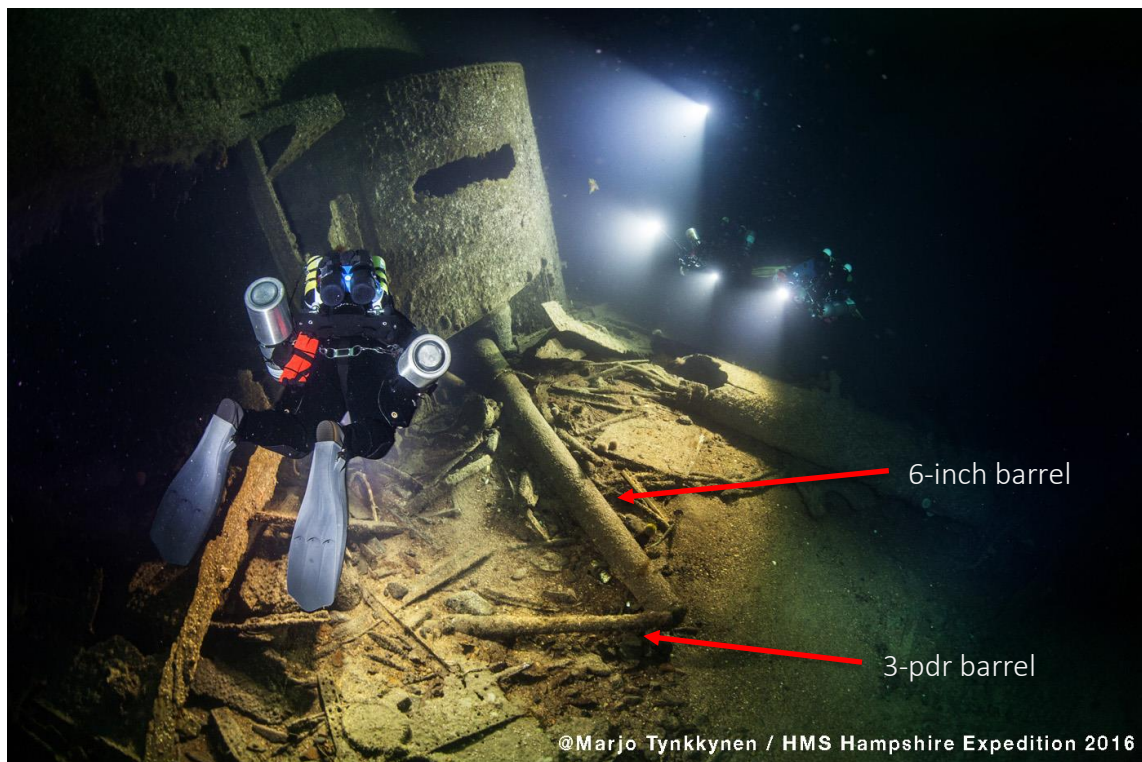
The lower of each of the two super-firing aftmost 6-inch casemate guns, X3 & Y3, were demounted in 1916 and moved to the Upper Deck in place of demounted 3-pdr QF guns. The lower casemate firing ports were then plated over to improve seakeeping. This plate can still be clearly seen on the port side – the plate has rotted through in the middle.

Figure 90: The superfiring Y1 6-inch gun barrel projects from the (now lower) firing port. The plated off lower 6-inch gun Y3 firing port can be seen above – its plate rusted through horizontally. The barrel of a buried QF 3-pdr rises up from the left to meet it

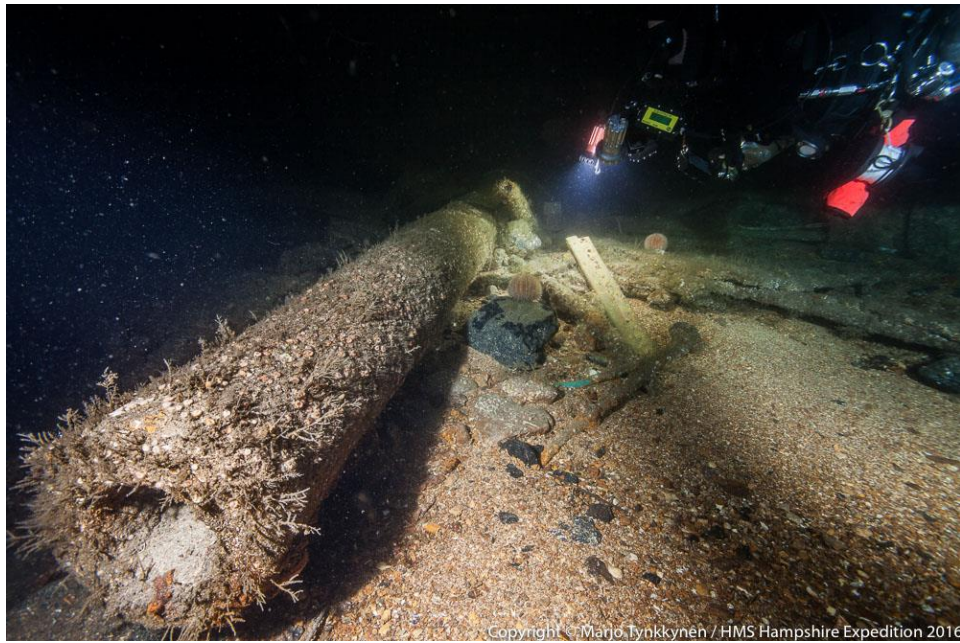
The aft port side casemate sits in situ and mostly intact except for parts of the casemate armour plate which has become detached from the main hull structure at the forward edge. Parts also lie on the seabed. The higher (now lower) Y1 6-inch gun barrel projects outwards and astern - its barrel lying flat on the seabed.

Figure 91: The upper 6-inch Y1 casemate gun barrel lies flat on the seabed pointing aft

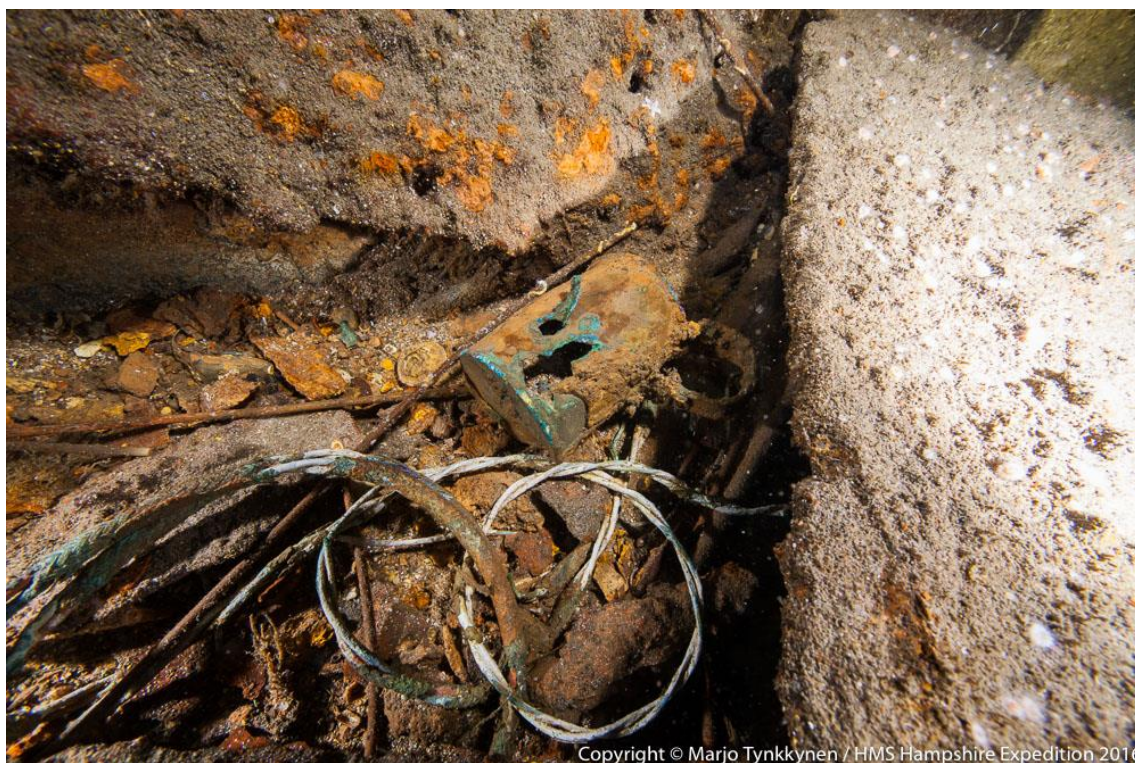
Figure 109: Copper jug and electrical wiring

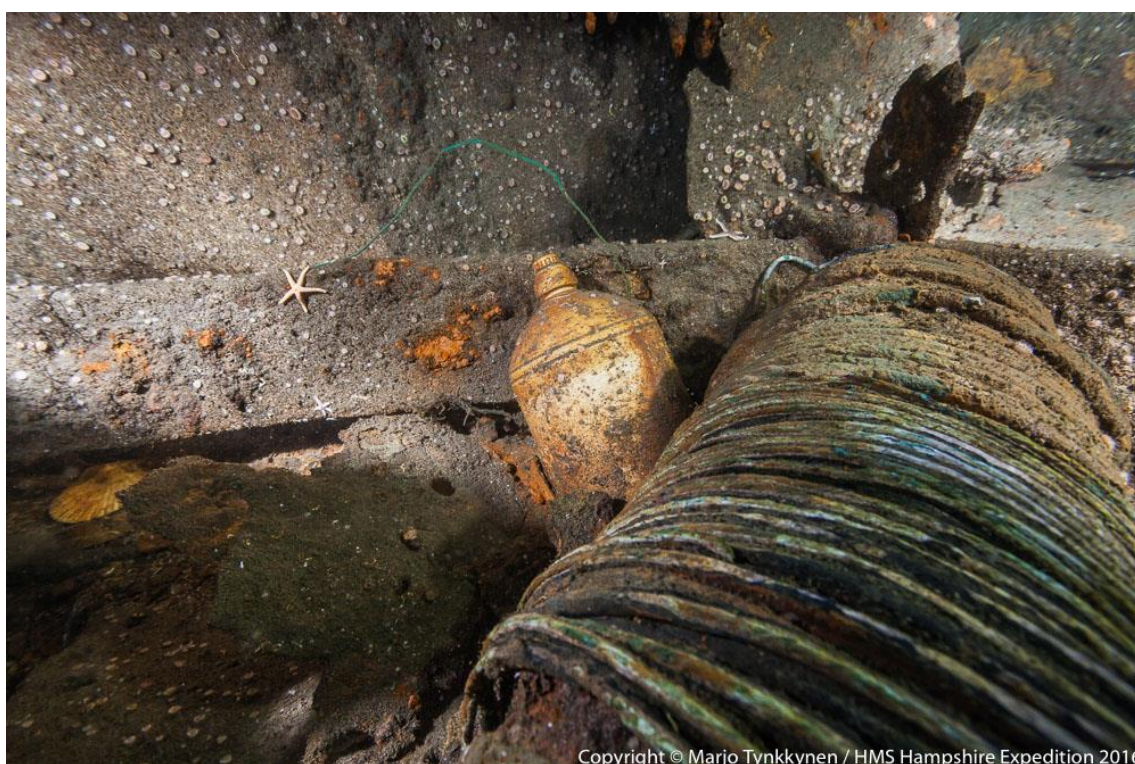
Figure 110: Earthenware container with intact stopper beside electric cabling,
on a wooden cable drum

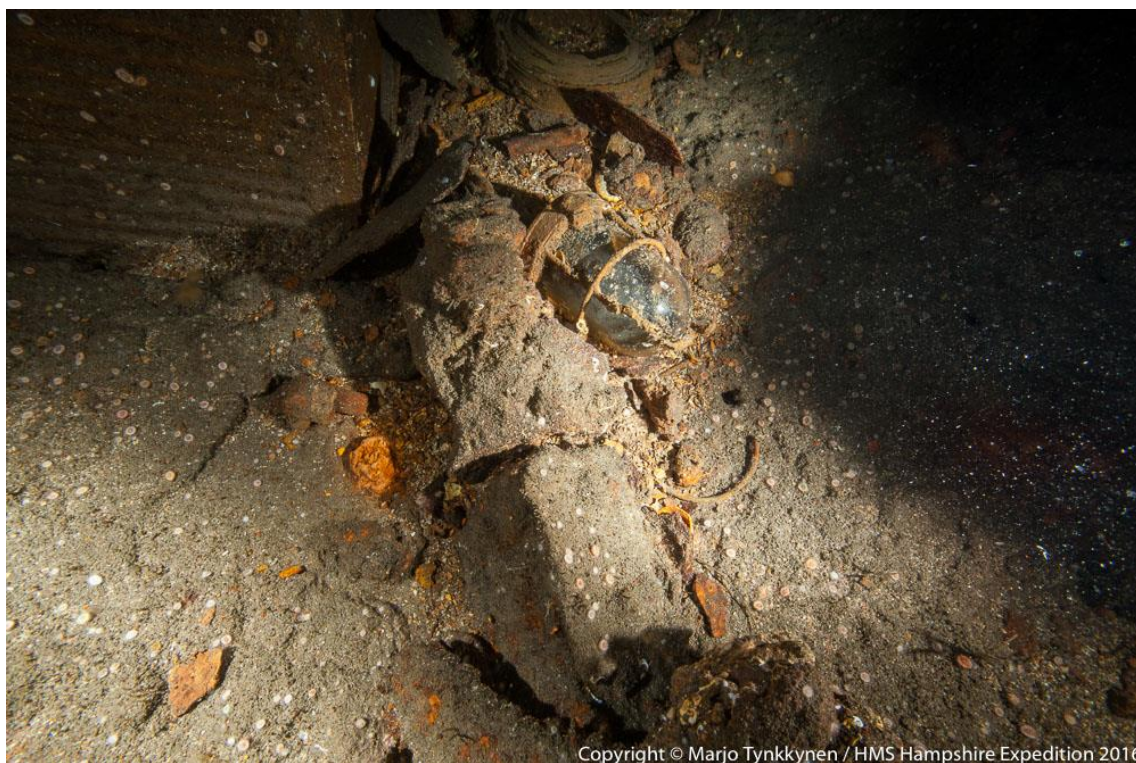
Figure 111: Brass cage lamp

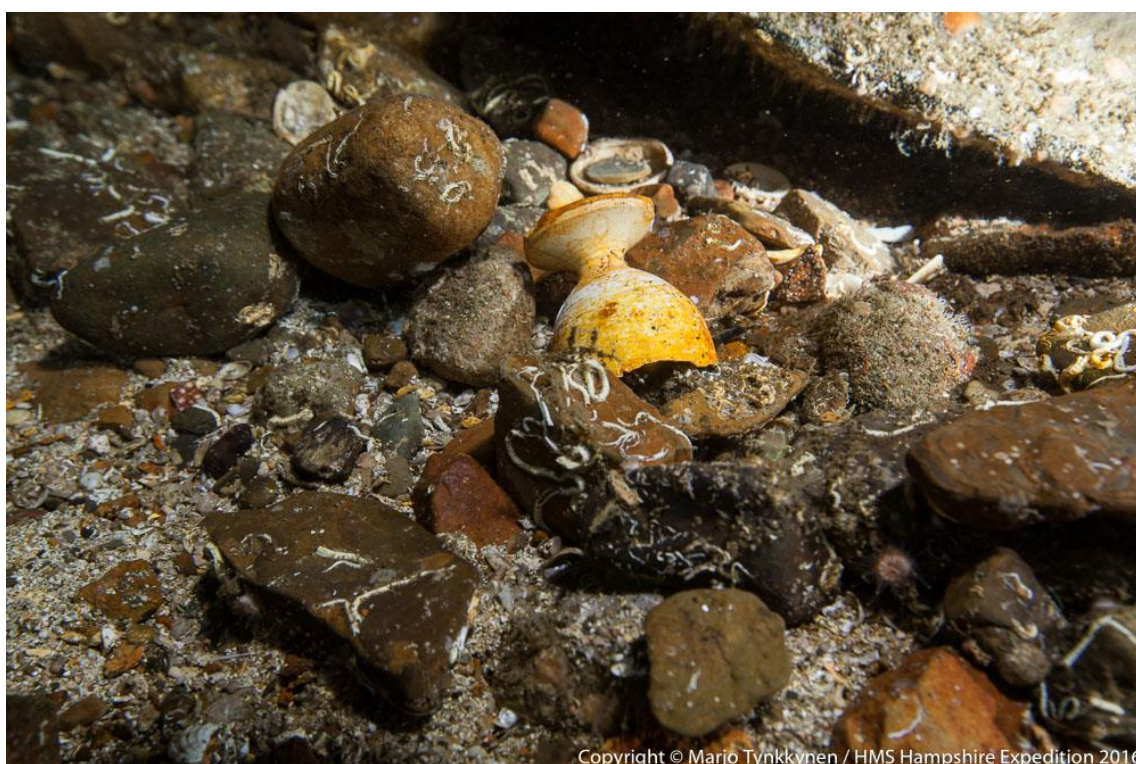
Figure 112: A single egg cup lies directly at the stern next to the ship's name

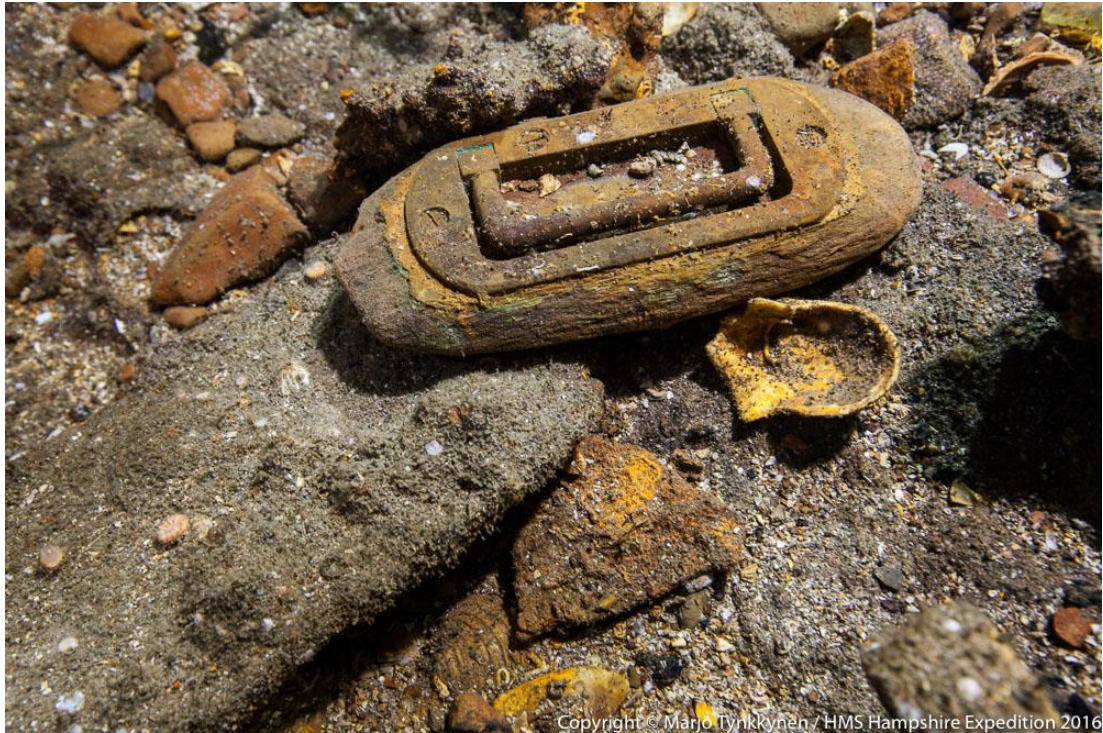
Figure 113: A brass drawer handle set into the remains of a drawer front.

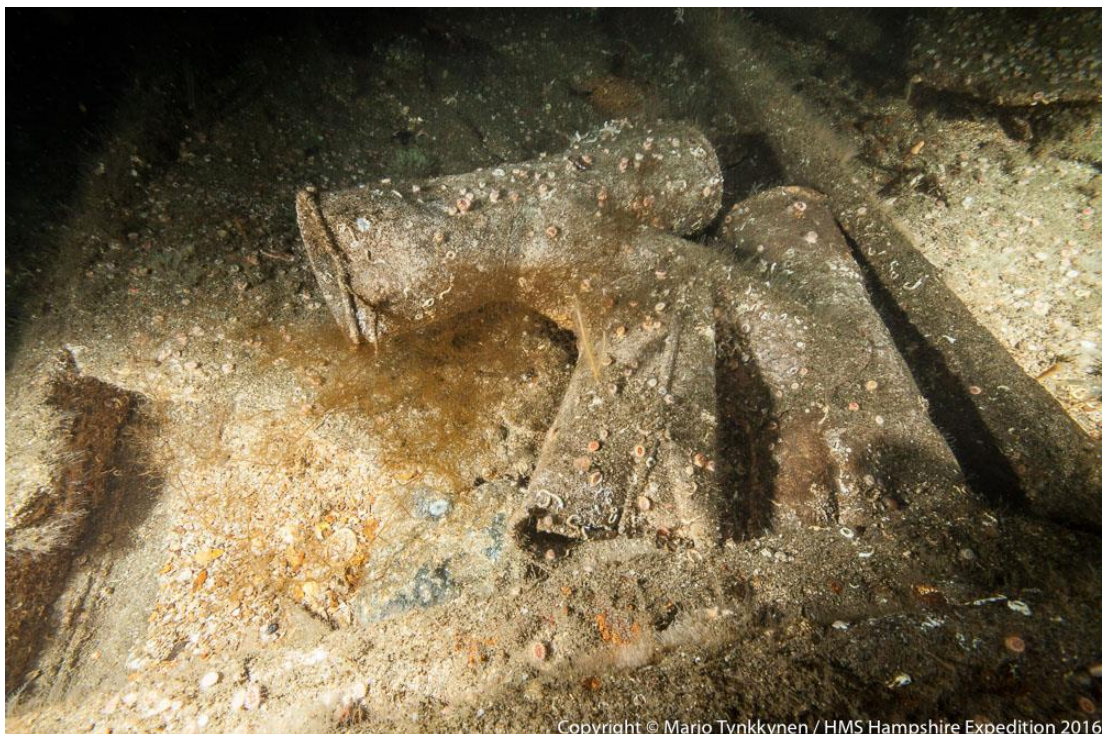
Several flue cowlings were located on the wreck. The example in the image below is located on the port side of the ship. To starboard there are several similar items partially buried in the seabed.

Figure 114: H-shaped flue cowl for a cabin stove

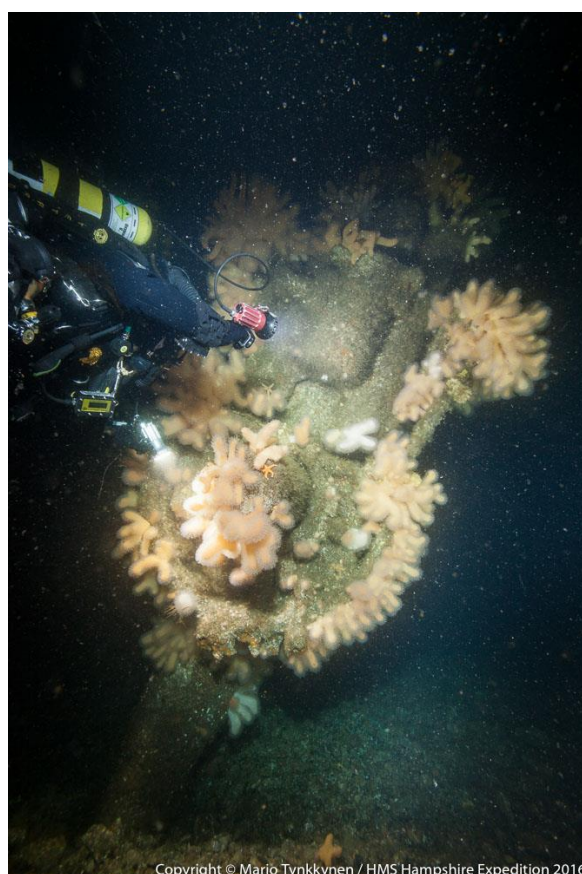
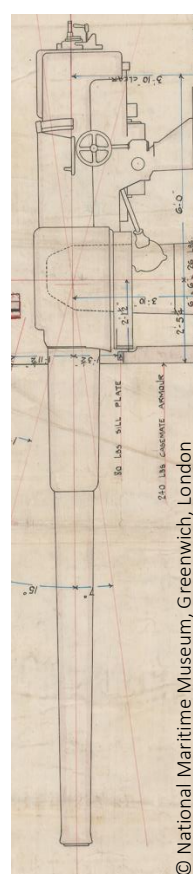
Figure 117: A second Vickers Mk VII 6-inch gun has fallen from its deck mount as the ship capsized. Its barrel has penetrated 4-5 metres into the seabed like a dart. Alongside is a schematic of the Mk VII 6-inch gun

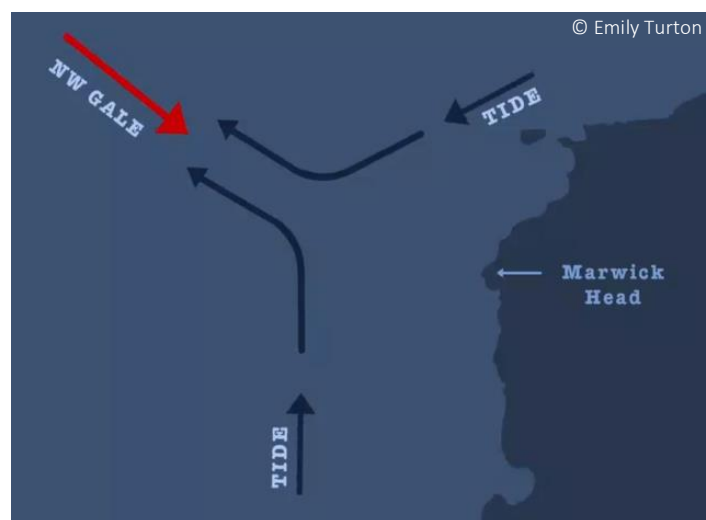
The tidal flow was setting to the north west at the time of her sinking. Once a sufficient proportion of the ship was underwater, the tide would have a greater effect than the wind and swell, causing her to pivot towards the north west moving over 40 metres from her original capsized position before settling on the seabed.

Figure 122: Diagram indicating wind direction and tidal direction on the evening of 5th June 1916

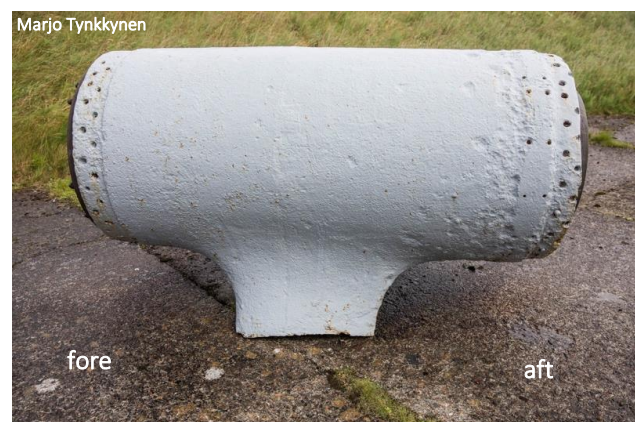
Examination of the footage of the remaining port A-frame clearly shows the cutlass bearing extends further aft than forward of its supports.

Figure 128: Comparison of starboard and port A-frames, detailing fore and aft position

This enabled us to orientate the A-frame and bearing at Lyness, such that the remaining short arm was the upper leg on the ship. The remaining long leg would have been attached to the keel.

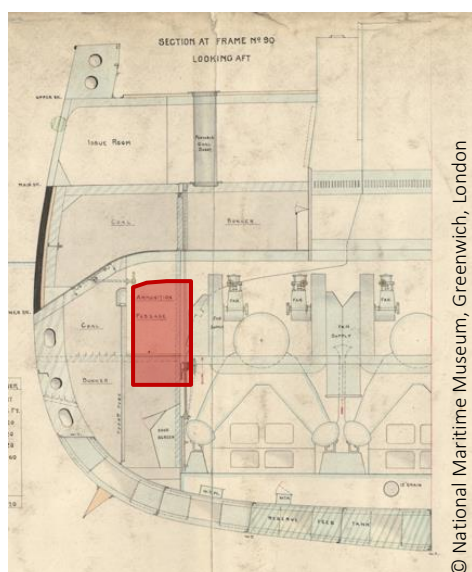
Figure 132: Cross section of the ship's plans showing port side ammunition passageway

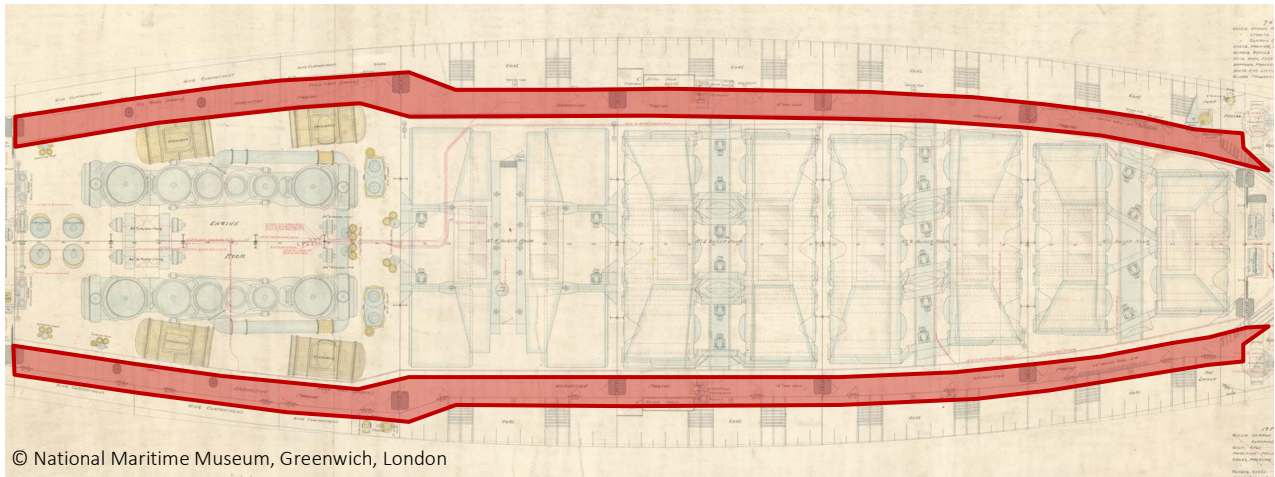
The starboard side fissure is much smaller. As the starboard vertical armour belt was in contact with the seabed at the time of sinking, the cause of the fissure must be entirely due to decay. The starboard longitudinal fissure, however, follows the same approximate pattern as on the port side of the hull. It is anticipated that both starboard and port longitudinal fissures will continue to grow and fracture the hull.

Figure 133: Ship's plans showing the location of the longitudinal ammunition passageways
